U.S. Army Toxic and Hazardous Materials Agency

TOOKLE ARMY DEPOT
PRELIMINARY ASSESSMENT/SITE INVESTIGATION
FINAL REPORT

VOLUME I
NORTH AREA AND FACILITIES AT HILL AIR FORCE BASE

DECEMBER 1988

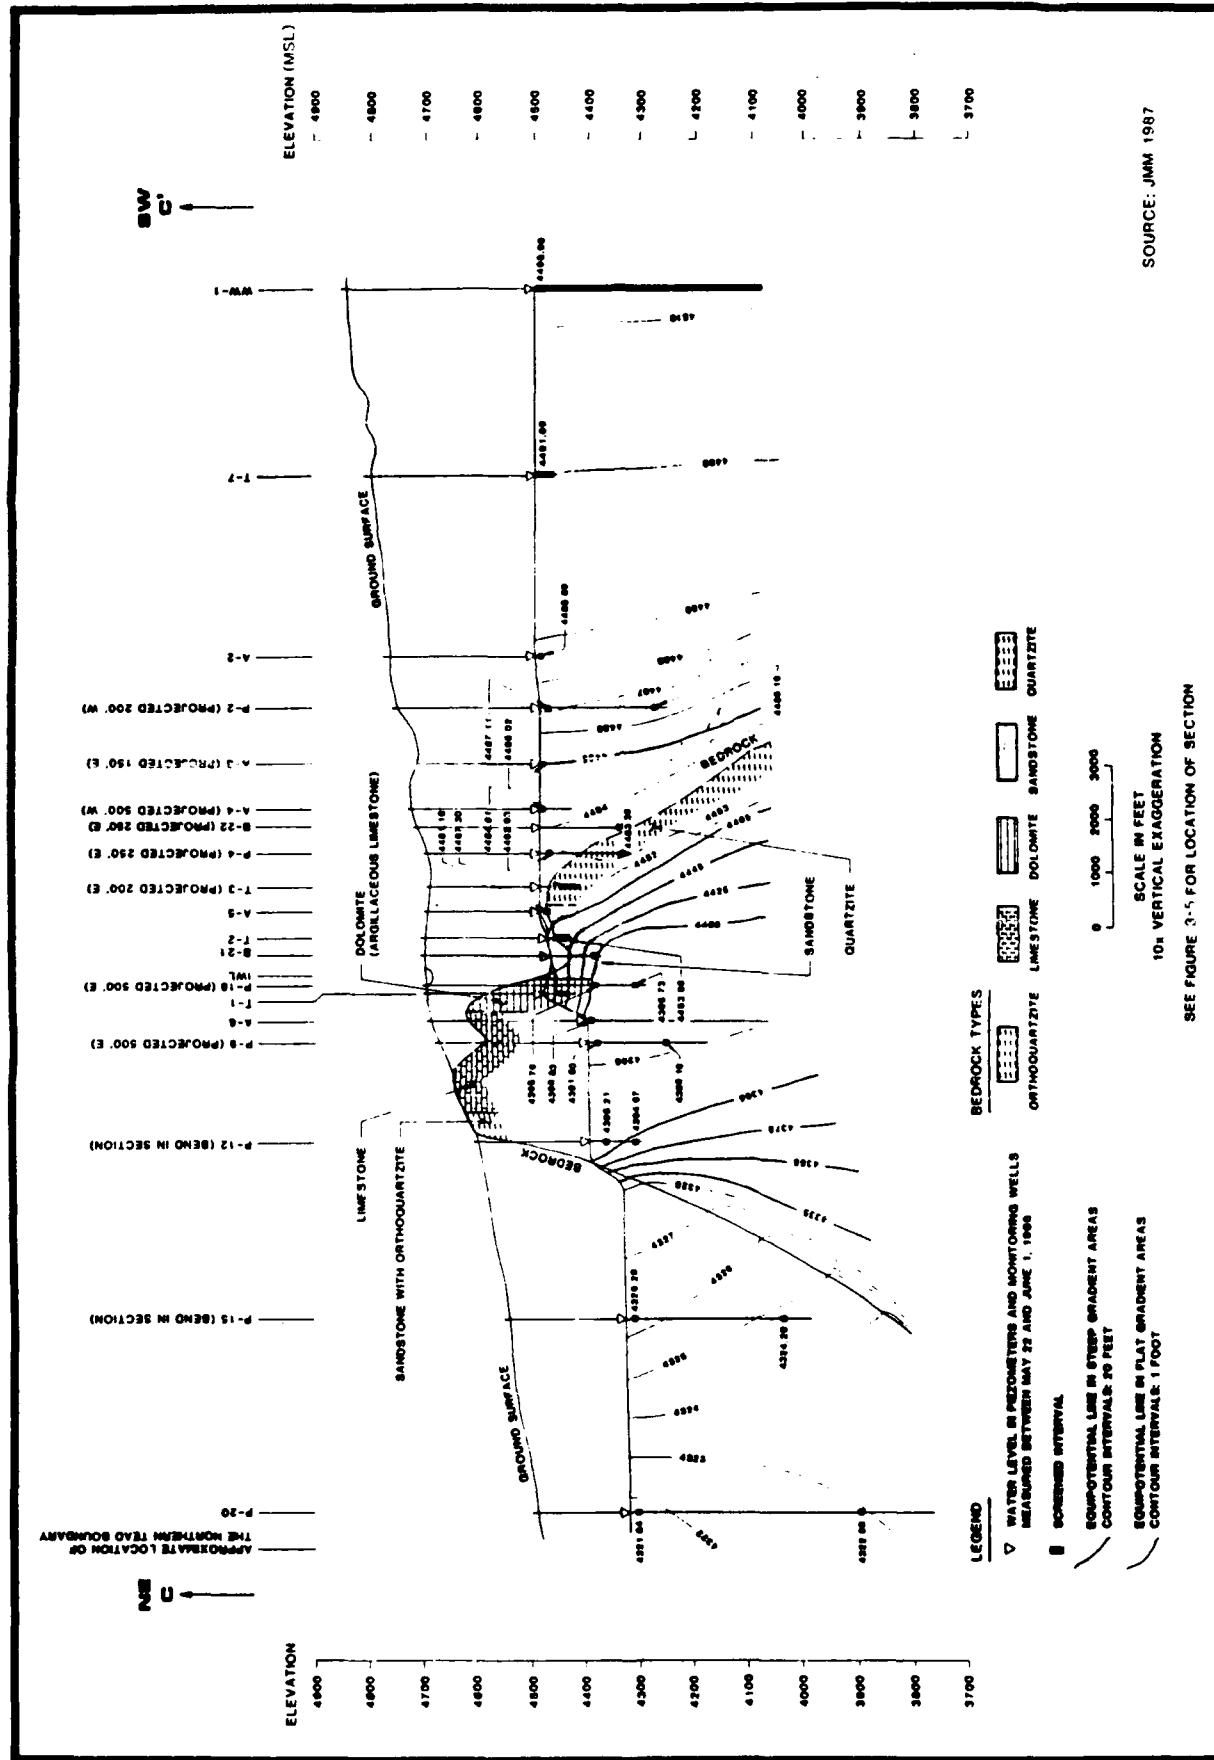
Figure 3-6. Generalized Hydrogeologic Cross-Section of The Industrial Waste Lagoon.

The presence of a groundwater mound and perched groundwater supported by localized clayey layers, has also been established in the vicinity of the IWL (JMM 1987). Figure 3-6 illustrates the complicated hydrogeology in this area of the depot. According to JMM (1987), groundwater enters the bedrock block in this area from the southeast, south, and northeast sides and then is retained by an apparent subsurface "dam," created by quartzite, limestone, and sandstone with clay-filled, silicified, or calcified fractures. Relatively steep potentiometric contours along the northern edge of the bedrock block reportedly indicate the presence of this dam. In an earlier study, Ertec (1982) reported the presence of a less permeable ridge in this area which was also hypothesized to "stack up" groundwater in this area. The observed pattern of relatively steep potentiometric contours along the northern edge of the bedrock block in this area may also be due to the sudden decline in hydraulic head created by fractures and faults in this area.

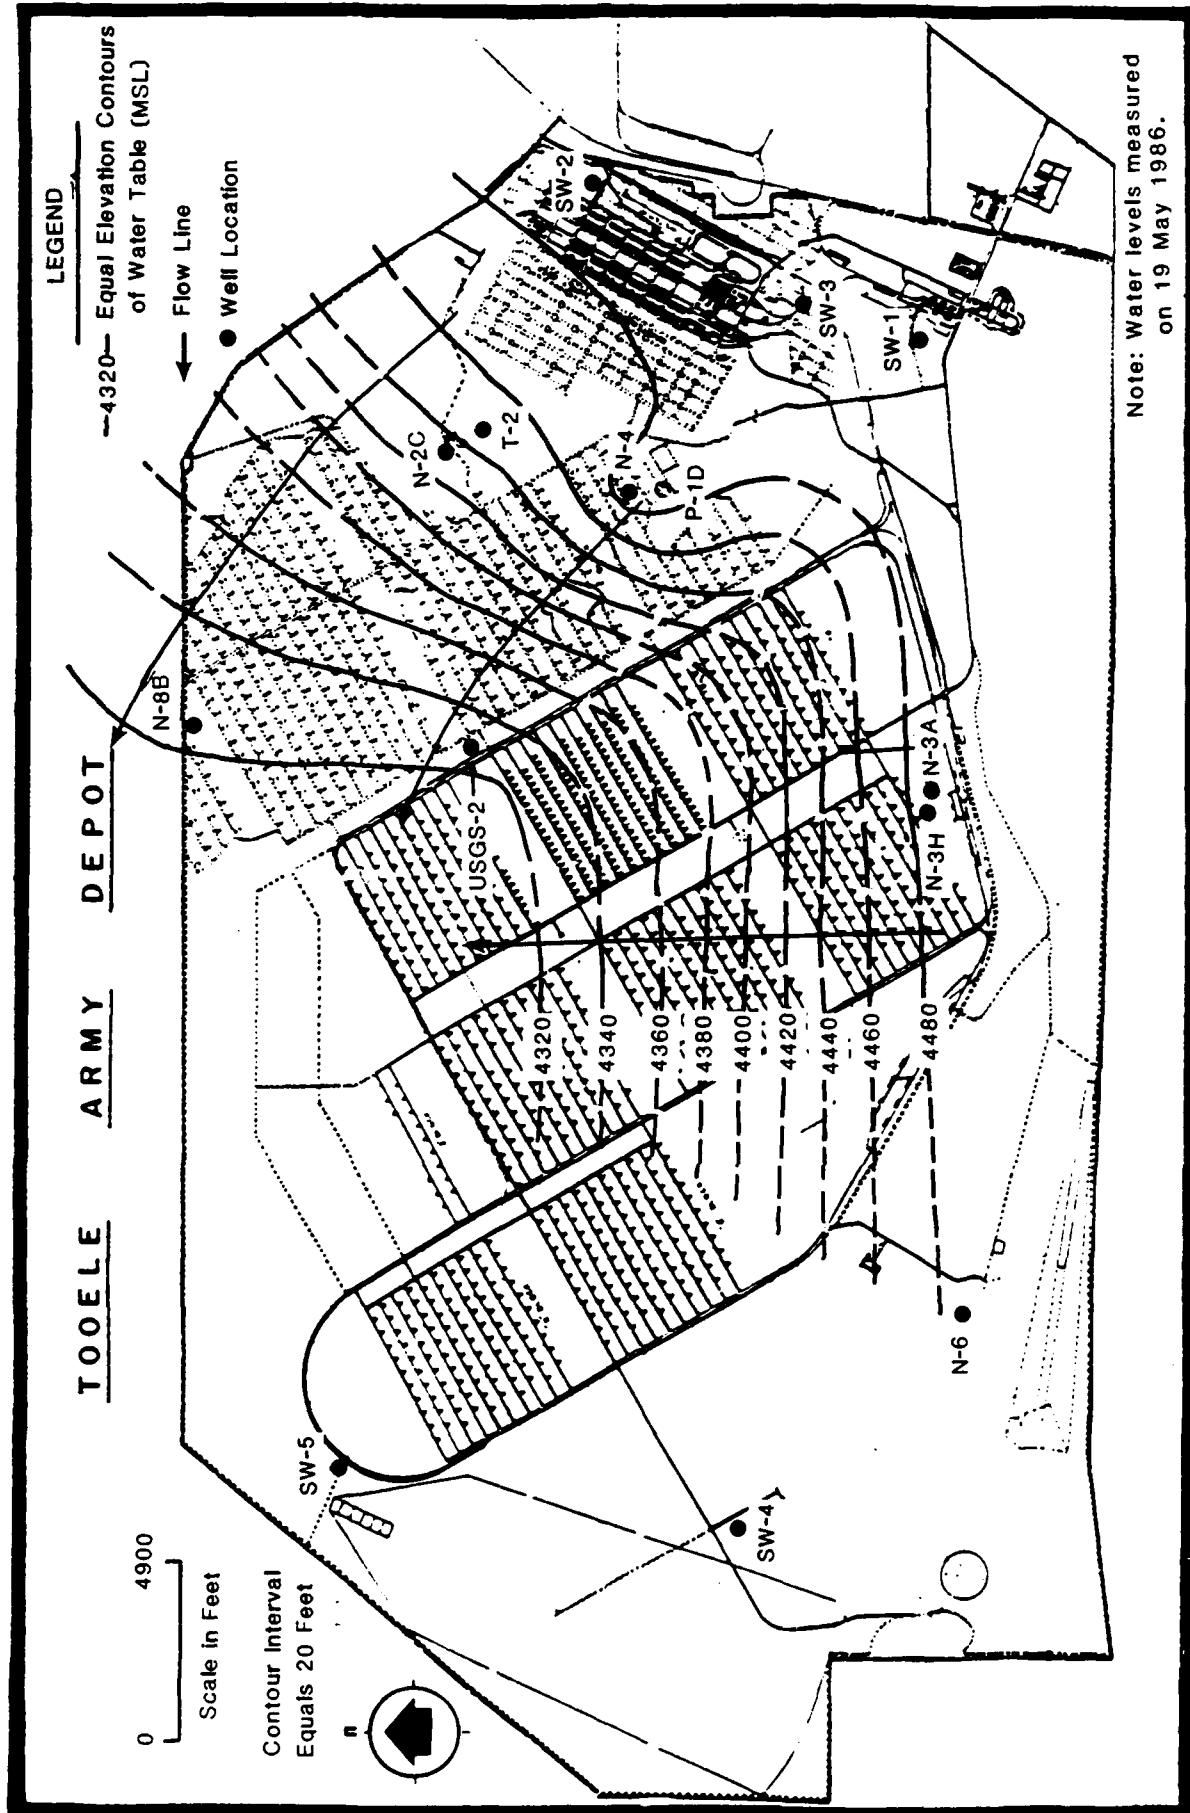
Figure 3-7. N-TEAD Potentiometric Surface Map.

Figure 3-7 shows a generalized potentiometric contours of the unconfined regional water table aquifer, based on static water level measurement data obtained on 19 May 1986 during this study (Table 3-2). The limited number and lack of water level measurement data for the wells in the western portion of N-TEAD, prohibited contouring of that area of the depot. As is indicated in Figure 3-7, the general direction of groundwater flow is from the east and south towards the center of the valley, and ultimately north to the Great Salt Lake. The depth to static water level at N-TEAD ranges from less than 200 feet in the north central area to over 600 feet in the southwest area.

Groundwater mounding from effluent seepage has been established in the vicinity of the sewage lagoons at N-TEAD. Well N-4 intercepts this mound about 1,200 feet from the lagoon. At this point, the top of the mound is approximately 34 feet above the predicted regional groundwater table. Flow lines in Figure 3-7 show the movement of groundwater away from the mounded area.

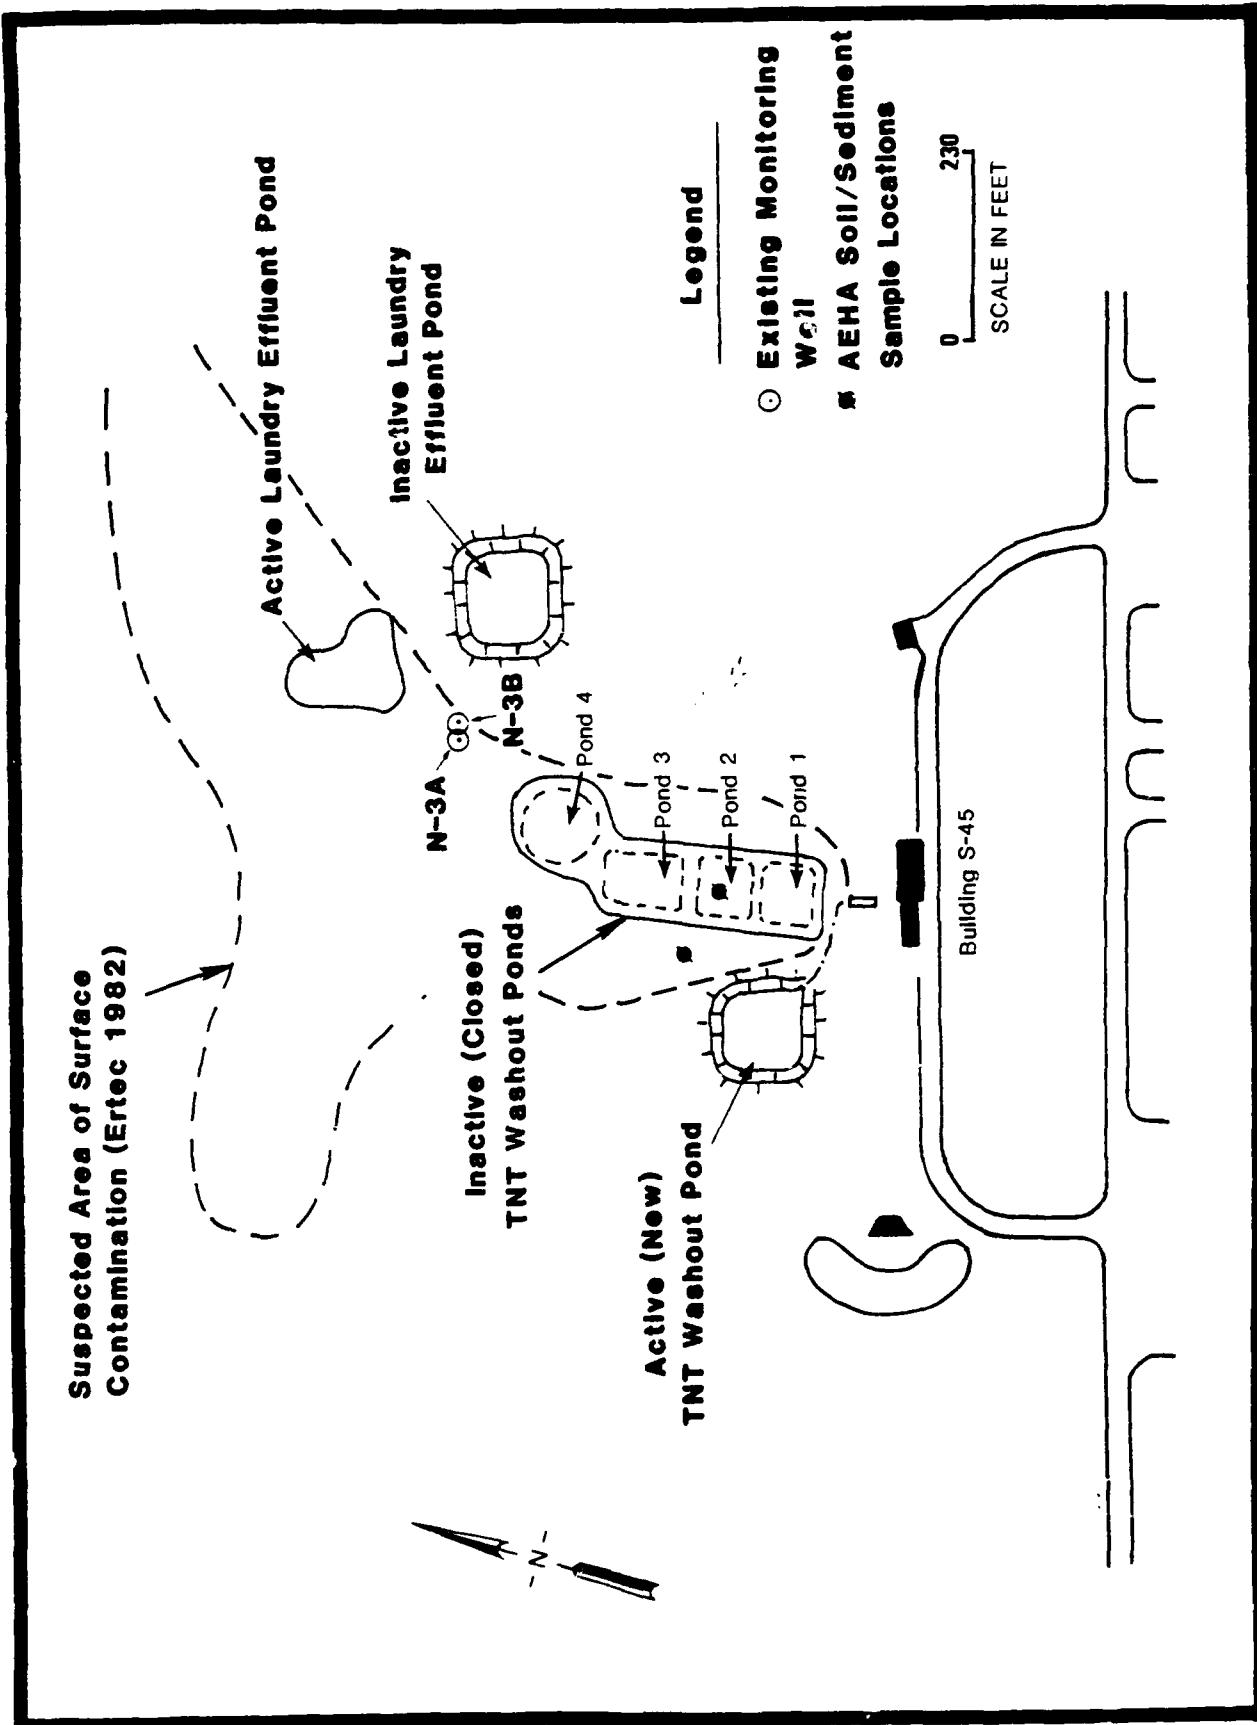
Figure 6-2. Site Map of TNT Washout Facility Area, N-TEAD

residual explosives during washout facility operation. The ponds were also reported to periodically overflow/flood onto the surrounding ground surface (Ertec 1982).

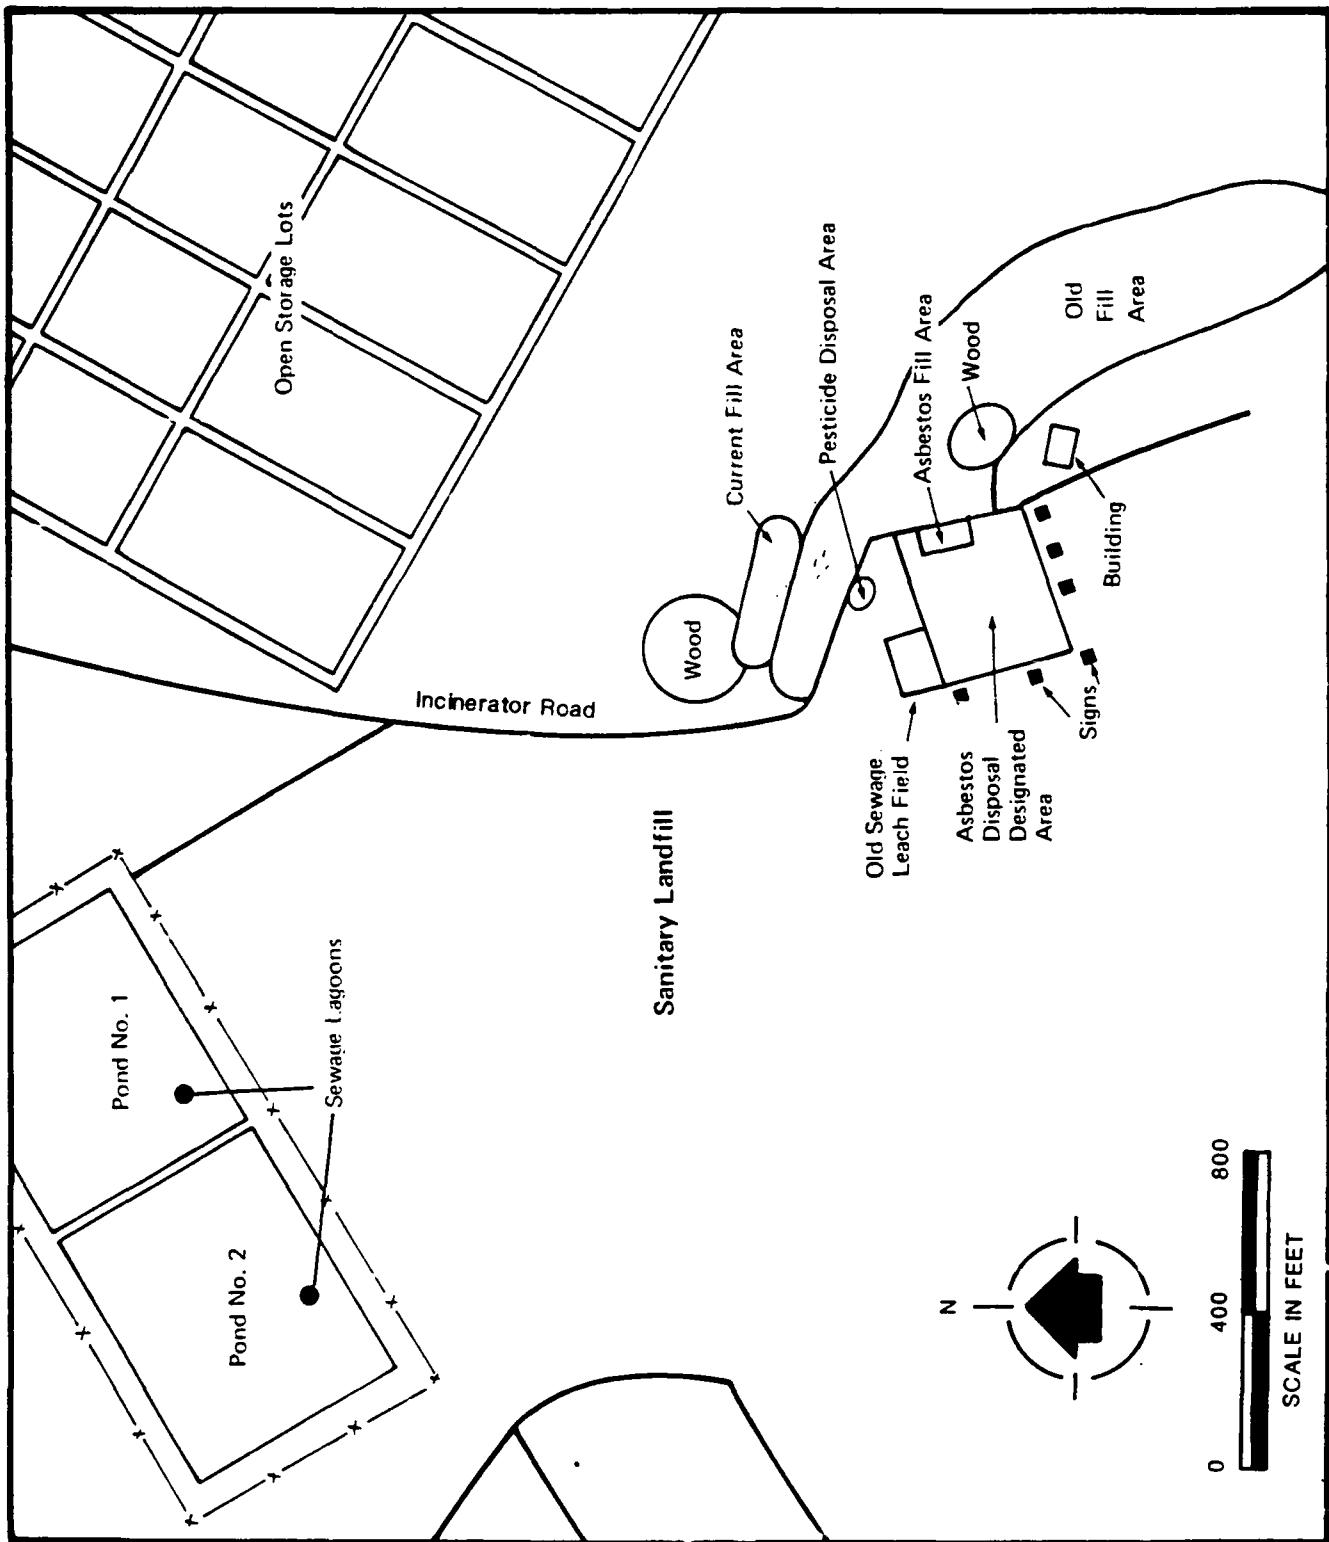
Figure 6-3. Site Map of Sanitary Landfill and Sewage Lagoons, N-TEAD.

The Sanitary Landfill is located in a natural depression approximately 1,200 feet southeast of the sewage lagoons in the eastern portion of N-TEAD (Figure 6-1). The fill area consists of two areas which are physically separated by Incinerator Road, covering a total area of approximately 75-90 acres (Figure 6-3). The major portion of the landfill is situated on the east side of Incinerator Road, where current landfilling operations are taking place. The landfilling operation

generally consists of placing the waste material in the natural depression and then covering it with alluvial deposits which are bulldozed from the upper rim. Cover material is placed over wastes every 2-3 months. Side slopes of the landfill are unstable and have broken away into the fill area during bulldozing operations.

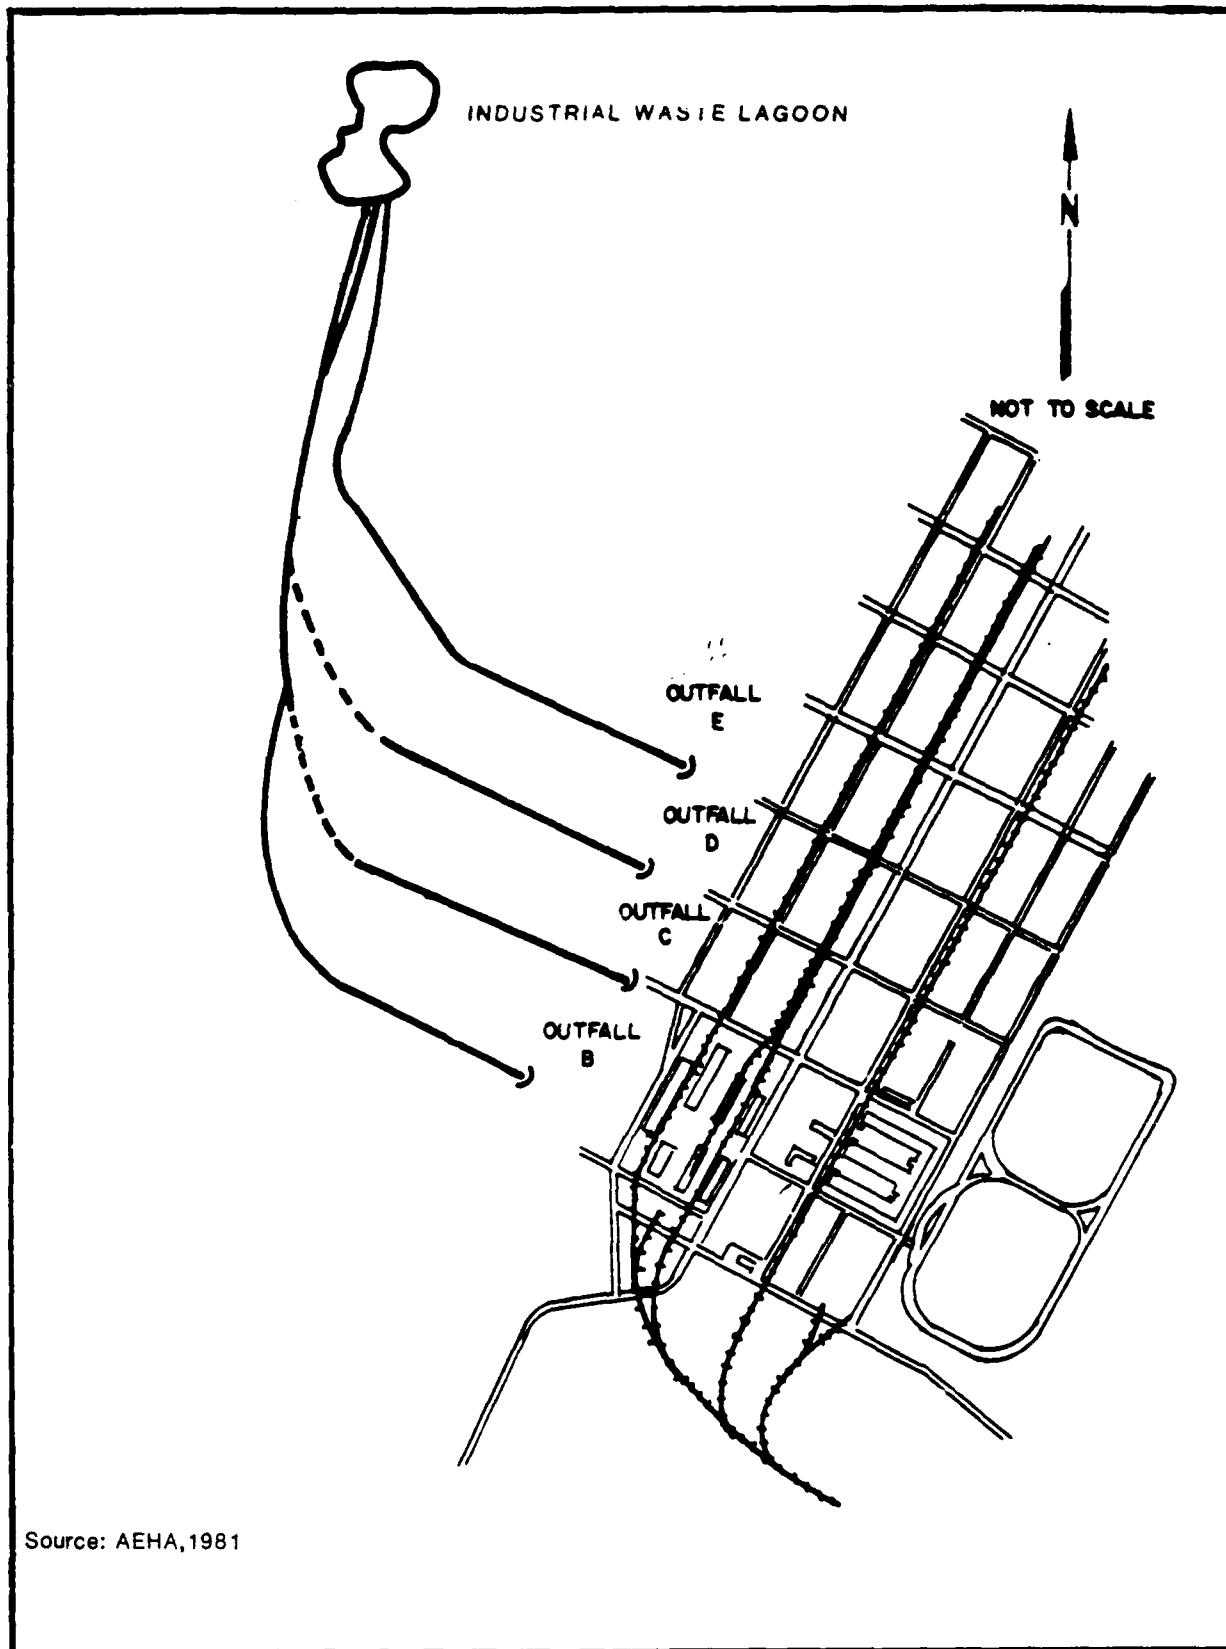
Figure 6-4. Site map of Industrial Waste Lagoon. N-TEAD.

The Industrial Waste Lagoon (IWL) is located in the eastern portion of N-TEAD, northwest of the Maintenance and Supply Area (Figure 6-1). The site consists of an unlined evaporation pond (approximately 125 feet by 250 feet) that receives wastewater containing solvents and heavy metals from the various industrial operations (degreasing, metal cleaning and stripping, steam cleaning, and painting) in the Maintenance and Supply Area. Industrial effluent is discharged to the lagoon via four unlined ditches (Figure 6-4). The IWL has operated for approximately 20 years and has recovered an average of more than 125,000 gallons per day of waste water. Approximately 96 percent of the wastewater reportedly

infiltrates into the ground through the unlined pond and conveyance ditches (JMM 1987). Seepage of wastewater through the ditches and lagoon has resulted in the contamination of groundwater in this area with volatile organic compounds such as trichloroethene (TCE), 1,1,1-trichloroethane (TCA), and carbon tetrachloride (CTC), and heavy metals such as chromium, cadmium, and lead (Ertec 1982; Woodward-Clyde Consultants 1985; JMM 1987). An extensive groundwater quality assessment program was being conducted at this site by JMM under contract with the Army Corps of Engineers, during this PA/SI effort, to evaluate the extent of groundwater contamination resulting from wastewater seepage from the ditches and IWL (JMM 1987). Consequently, this site was not included in the installation PA/SI Field Program.

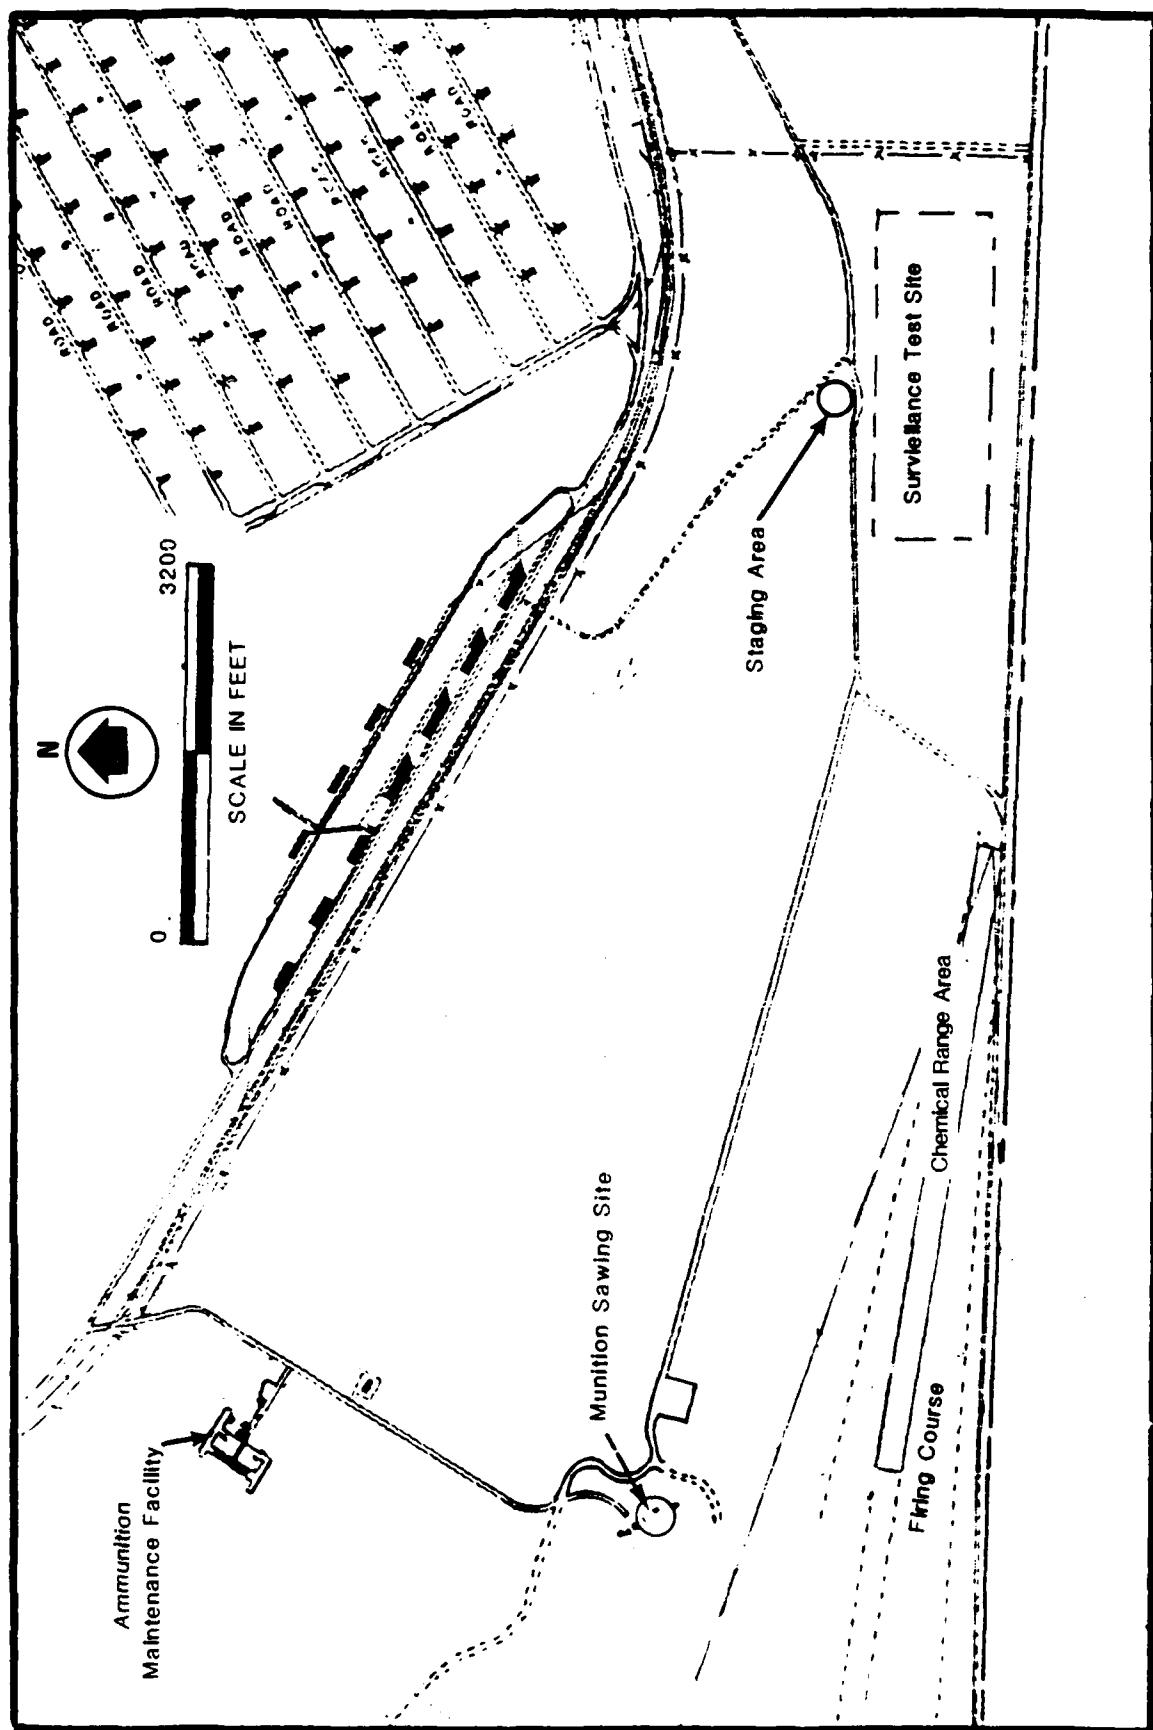
Figure 6-7. Site Map of Surveillance Test Site and Staging Area, N-TEAD.

A revetted area (test area) is located in the eastern portion of the site. Pieces of grenades, detonators, metal, and melted glass were observed during the 19 February 1987 site inspection. A large field, approximately 1/4 mile by 1/2 mile, is located just west of the test site. The area slopes from south to north and has undulating areas which appeared to be filled trenches that have been graded.

The EPIC photographs indicated that trenches were located in the field and suggests the area was used as a burning and burial area. The photos indicate trenches were also located in several other areas of the site in the past.

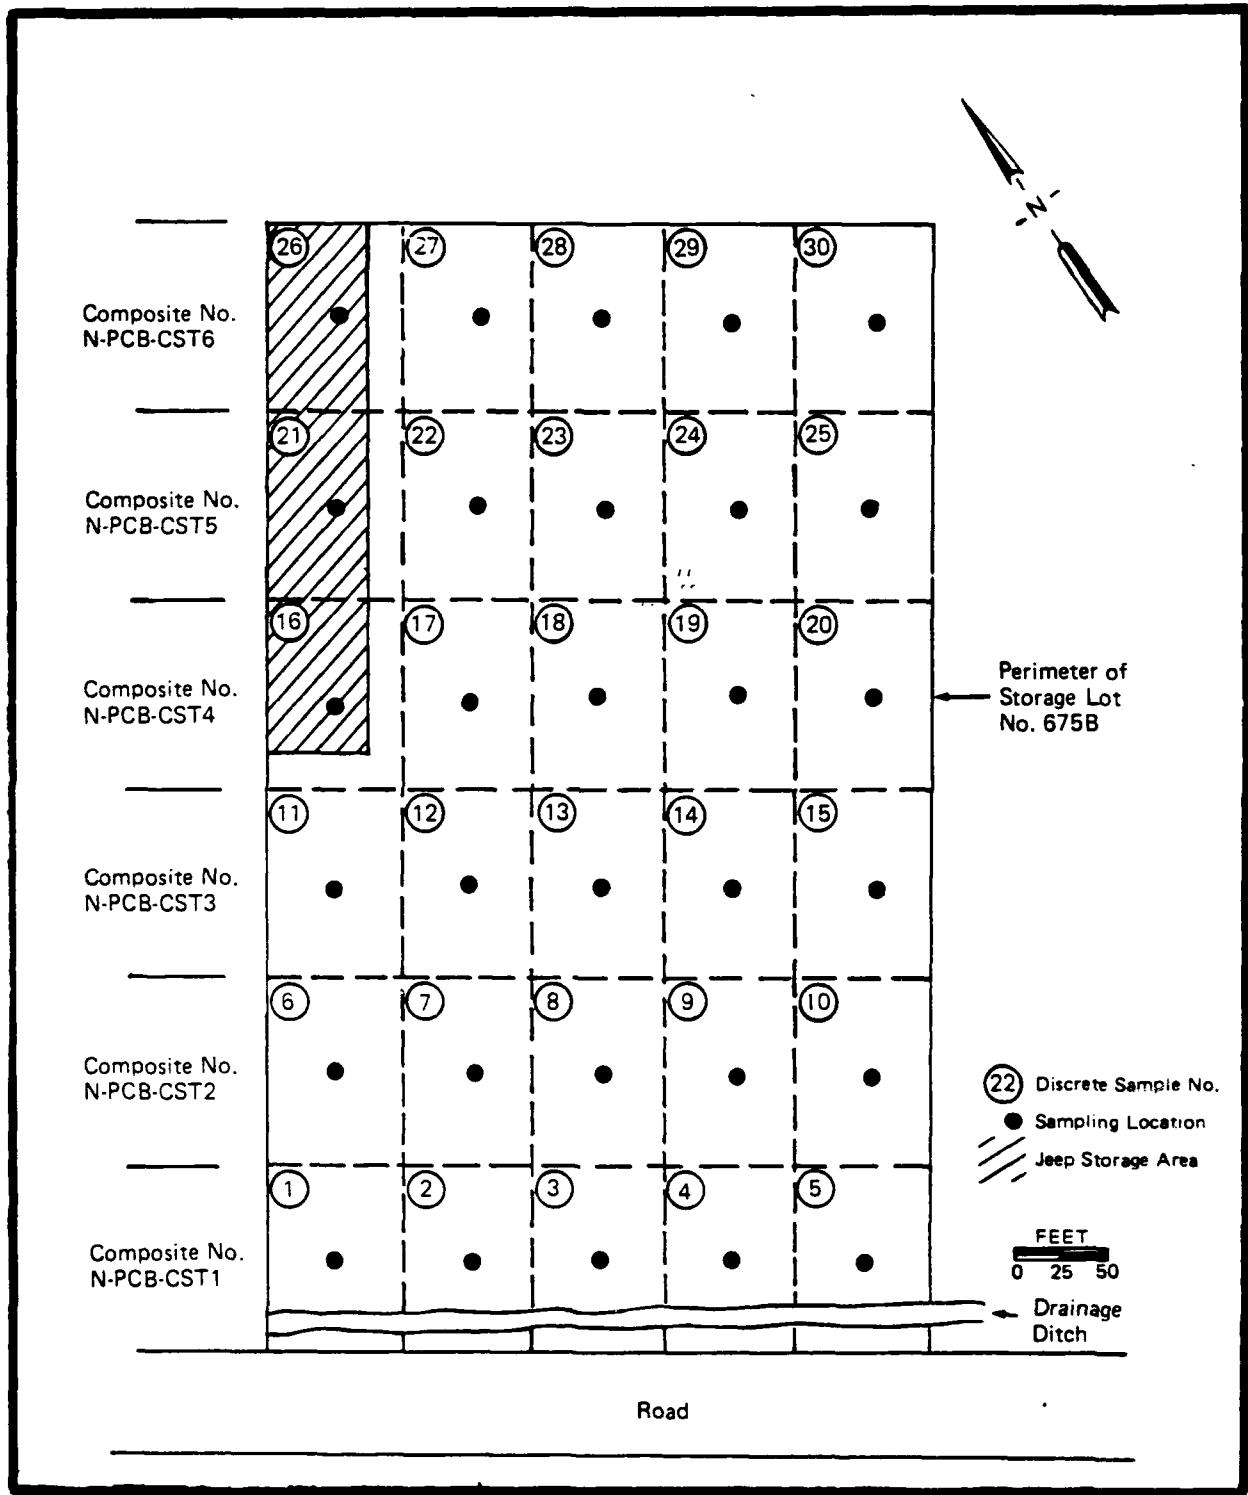
Figure 8-6. Sketch of N-TEAD Former Transformer Open Storage Lot No. 675B Showing Sampling Locations.

Composite soil samples were analyzed for PCB Aroclors 1016, 1254, and 1260. The analytical results are summarized in Table 8-6. PCB Aroclor 1016 was below detection limits in all composite samples. Composite samples, N-PCB-CST3 showed a detectable level of Aroclor 1254, at 0.0191 $\mu\text{g/g}$. Aroclor 1260 was detected in only two composite soil samples, N-PCB-CST5 and N-PCB-CST6, at 0.108 and 0.100 $\mu\text{g/g}$, respectively.

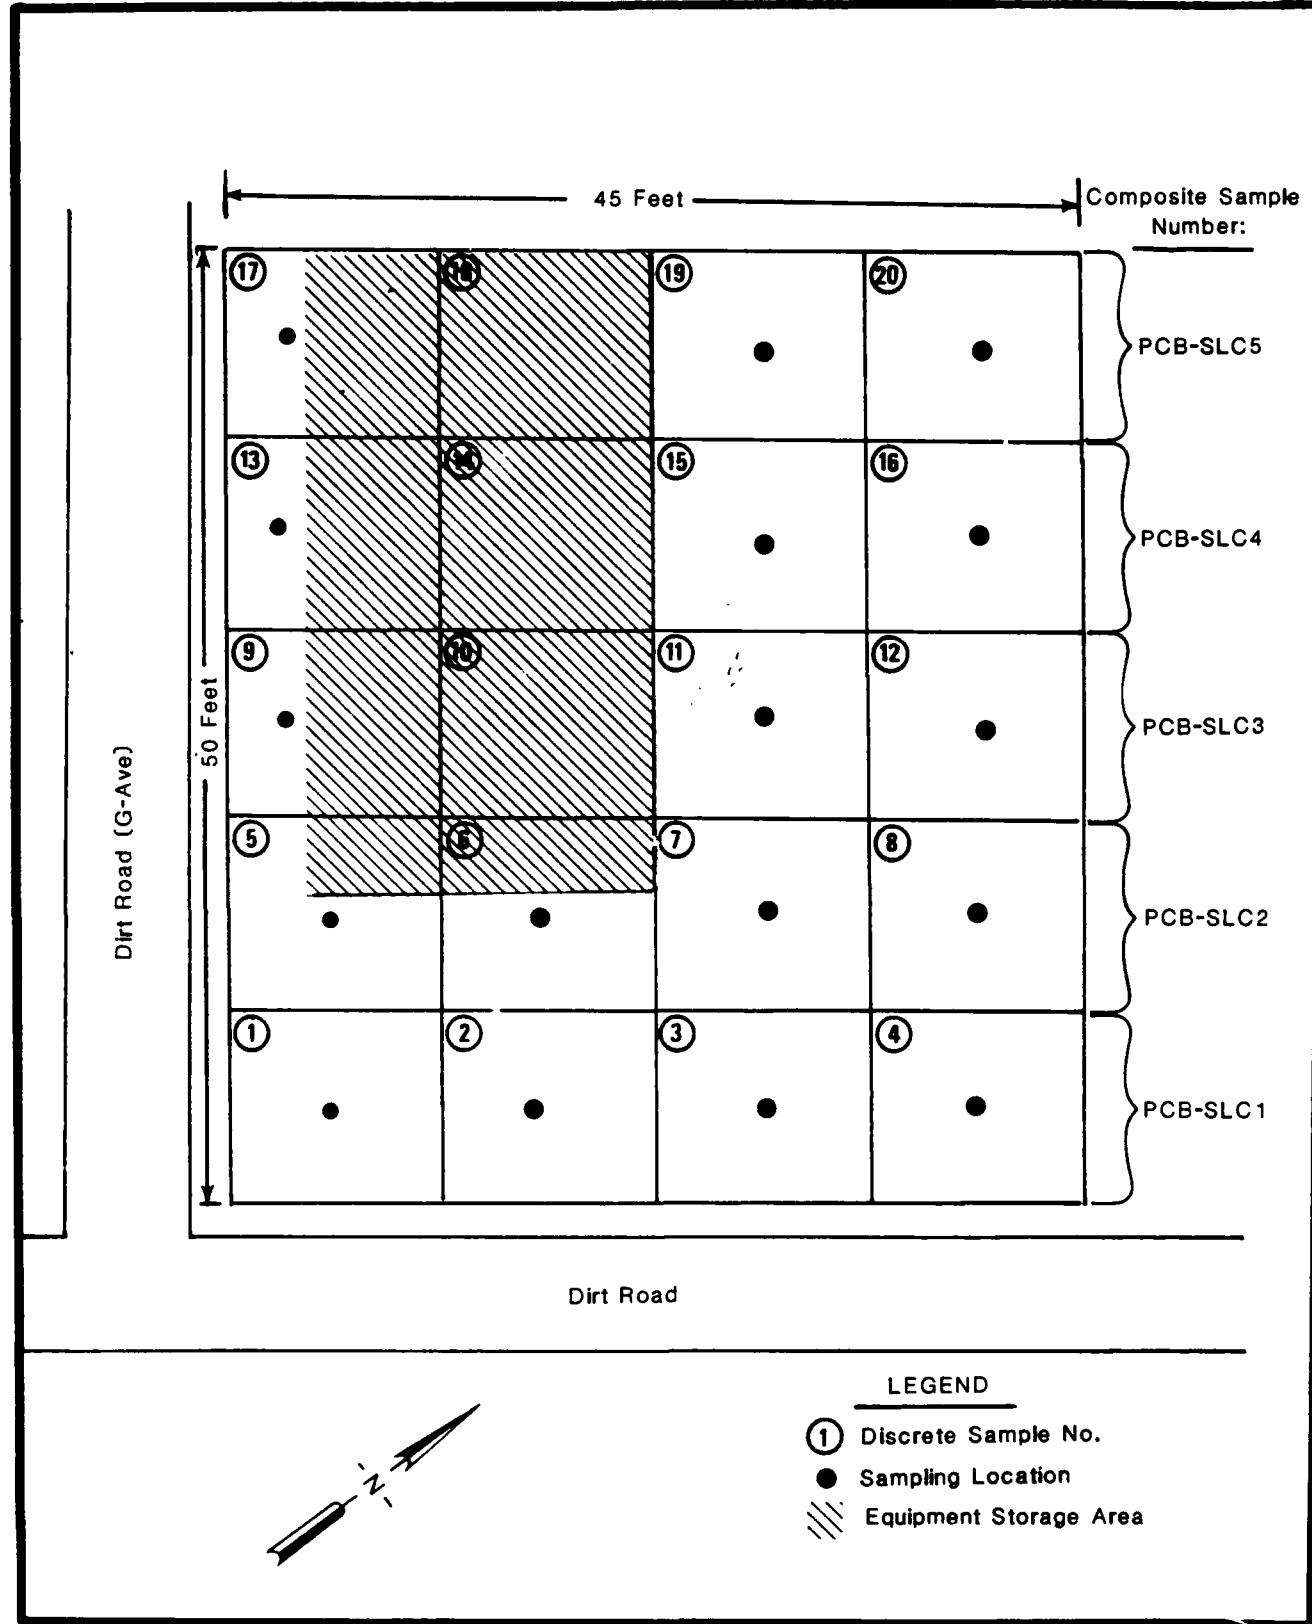
Figure 8-7. Sketch of PCB Spill Site, N-TEAD, Showing Sampling Locations.

Prior to conducting soil sampling, the site was gridded into 20 quadrants² (Figure 8-7). The total sampling area covered approximately 2250 feet² (45 feet X 50 feet). Each quadrant was approximately 9 feet X 10 feet in size. Soil samples were collected at the center of each quadrant. A total of 17 discrete samples were collected using a stainless steel hand trowel and placed in separate labeled sample bottles. Soil samples could not be collected from three of the quadrants due to the presence of stored equipment covering these areas (Figure 8-7).

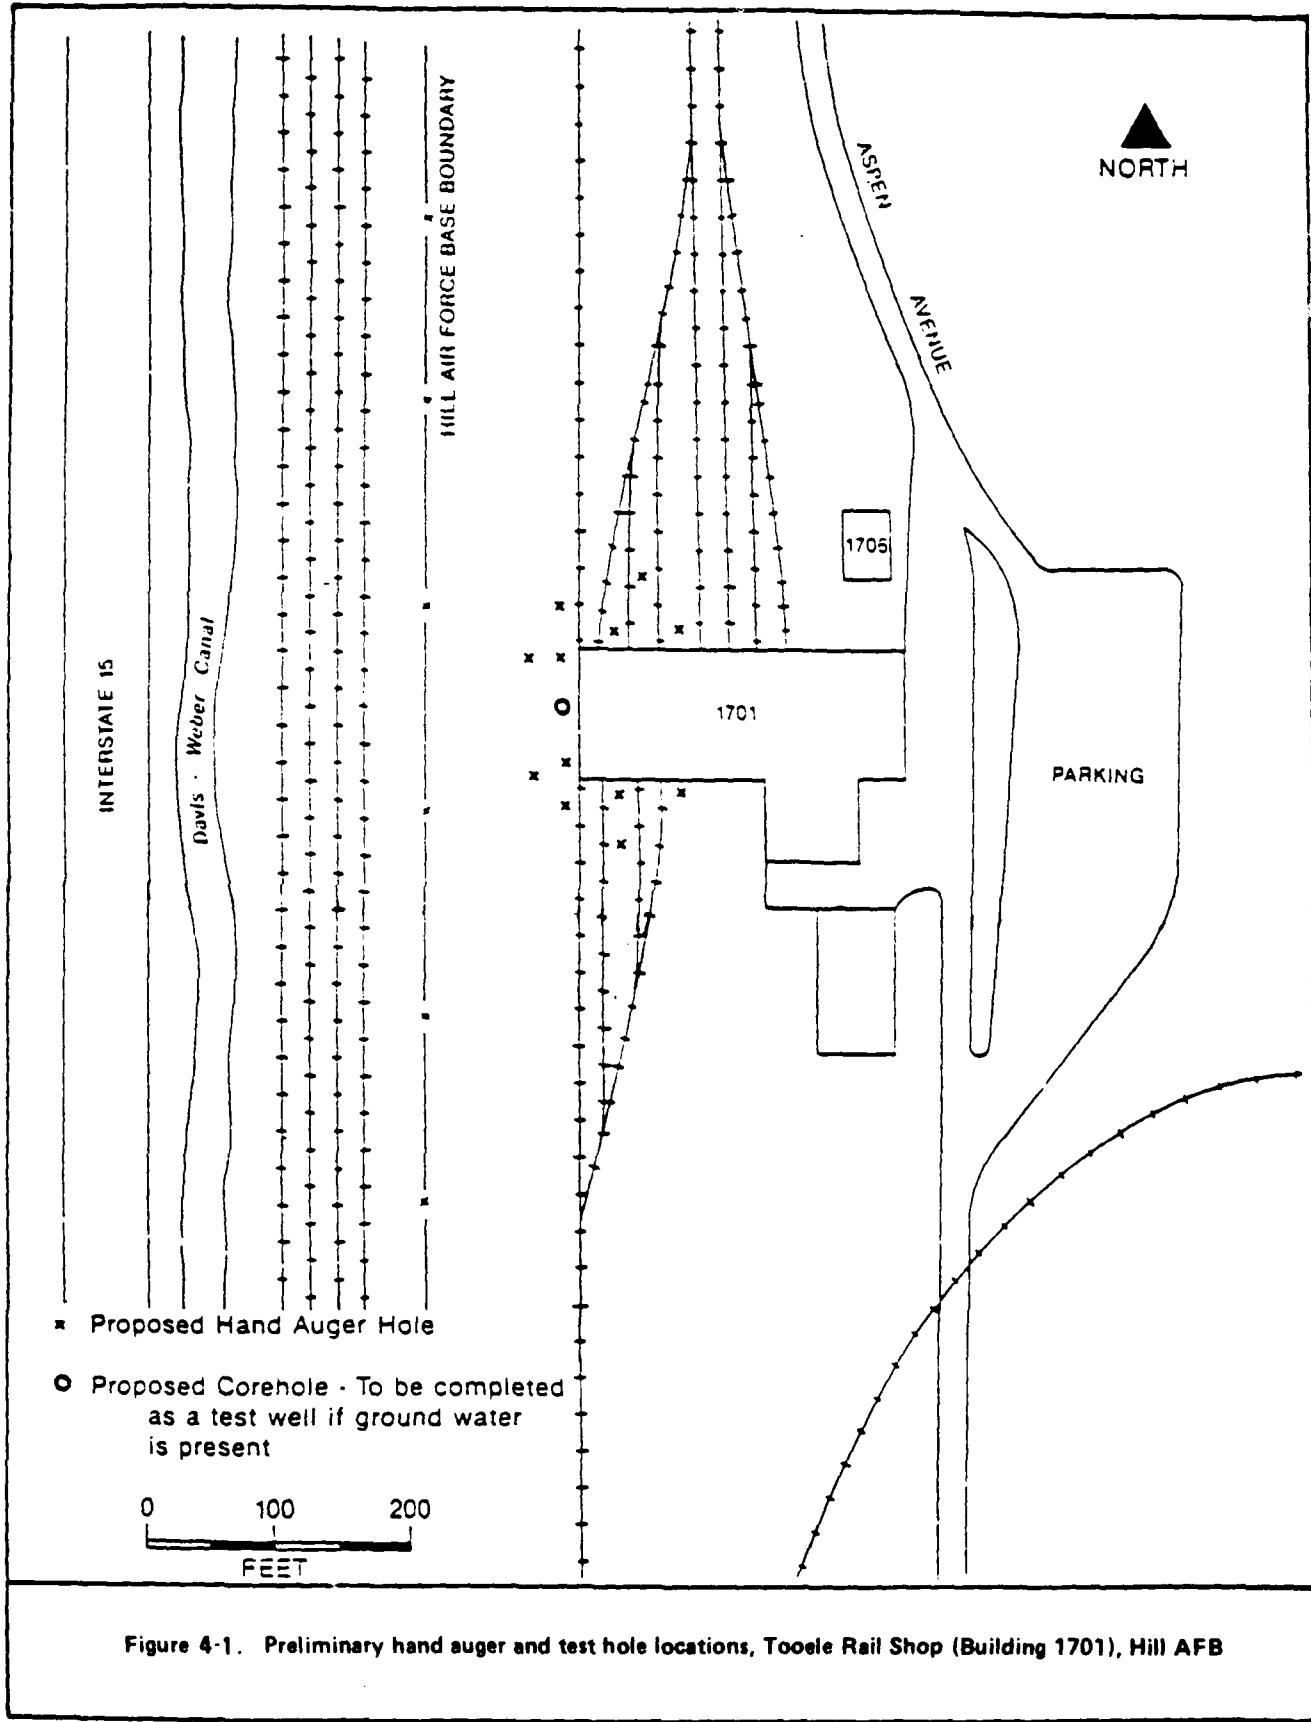
Figure 4-1. Preliminary hand auger and test hole locations, Tooele Rail Shop (Building 1701), Hill AFB

The Tooele Rail Shop has been included in the U.S. Air Force's IRP Phase II investigation of sites at HAFB because of the age of the facility and the potential for soils in the vicinity of the site to be contaminated. The purpose of the Phase II site investigation is to define and quantify the presence or absence of contamination resulting from past activities at a site that may have an adverse impact on public health or the environment. Phase II investigative activities at HAFB are presently ongoing and involves the performance of the following activities in the TEAD Rail Shop Facility Area:
